The Columbia Accident

Ballistic Research Supporting the Accident Investigation

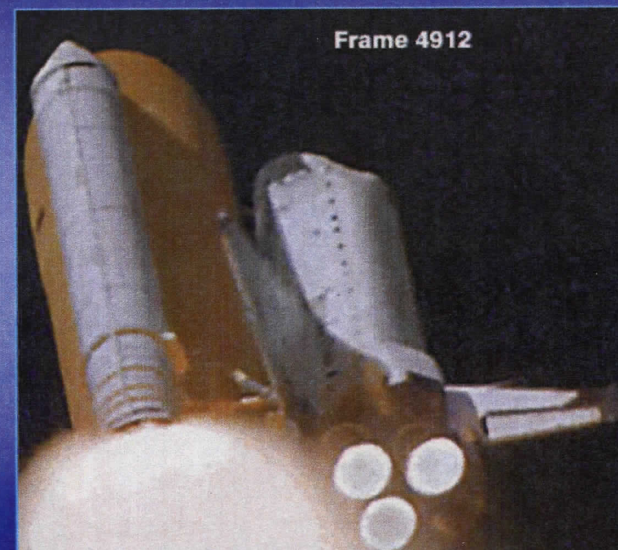
On January 16 2003, Columbia's leading edge was impacted by a piece of foam suspected to have separated from the external tank bipod ramp at 81 seconds into its launch.

Columbia was traveling at Mach 2.46, at an altitude of 65,860 feet. The foam was calculated to have hit the Orbiter at 700 – 800 feet per second

Insulating Foam Separates from Bipod Ramp and Impacts Left Wing of Columbia

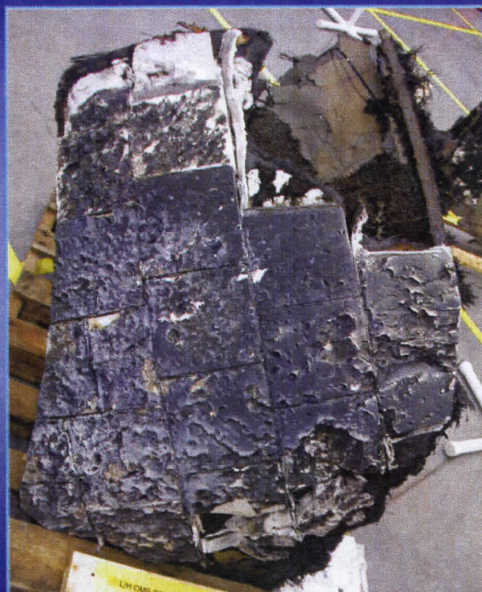
Exiting debris impact OMS
Pod and Tail Section

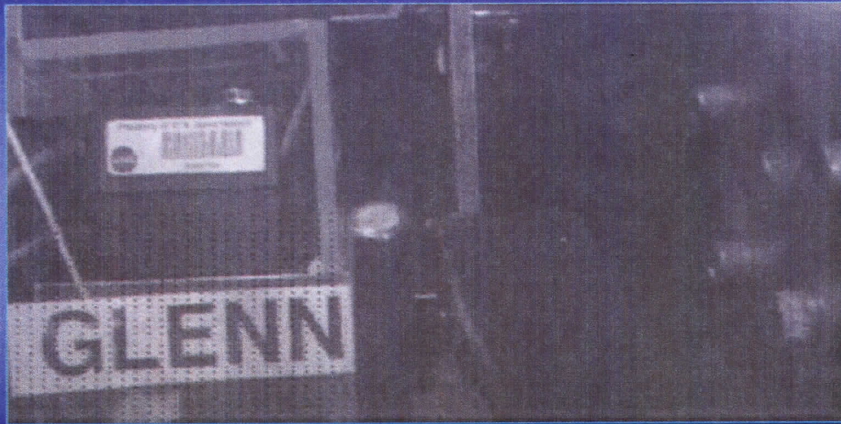
RCC Coupon Shows No Damage After 397 ft/sec Foam Impact

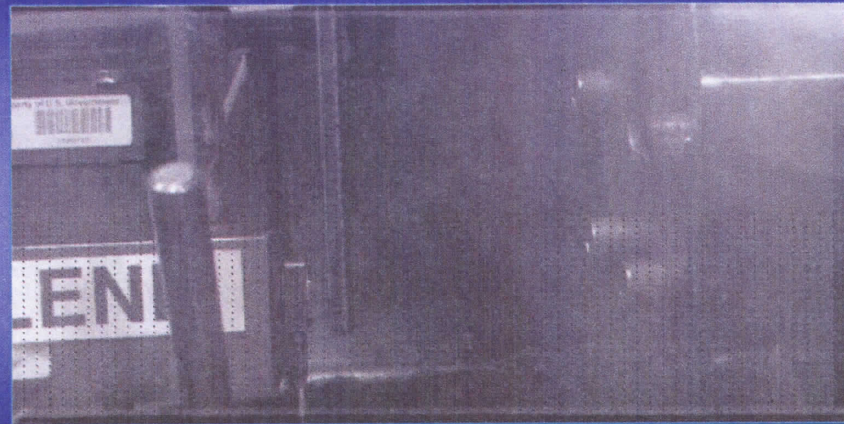
Foam Fractures RCC coupon in half at 695 ft/sec

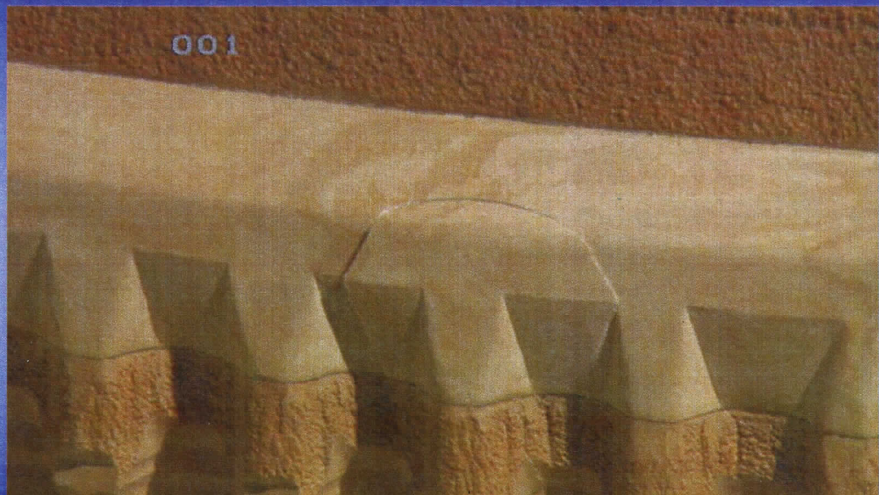
Foam failure at LOX intertank flange which Initiated Investigation

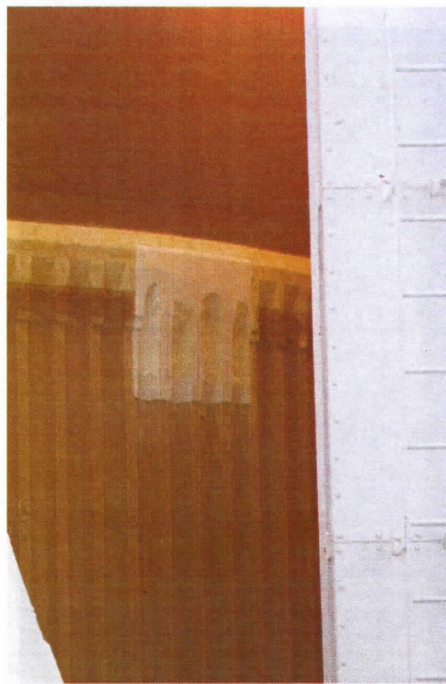
Repair on damaged foam will be first area of interest to be imaged during tanking with the Aramis system.
